BMP Retrofit Pilot Program

FINAL REPORT

REPORT ID CTSW - RT - 01 - 050

California Department of Transportation

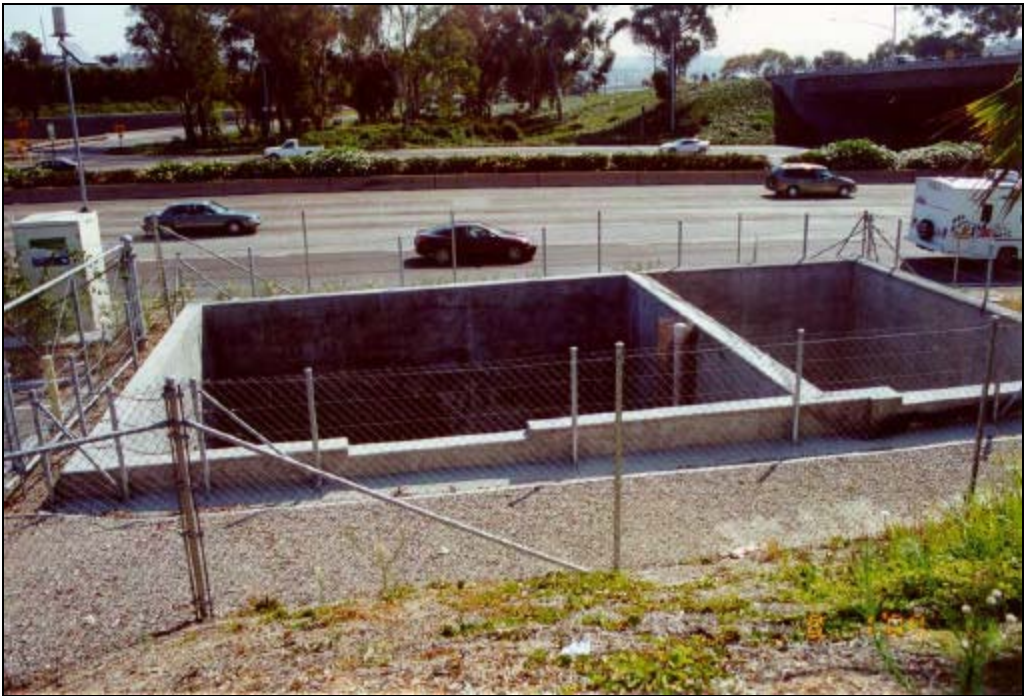
Figure 2-2 I-5/SR-78 Austin Sand Filter

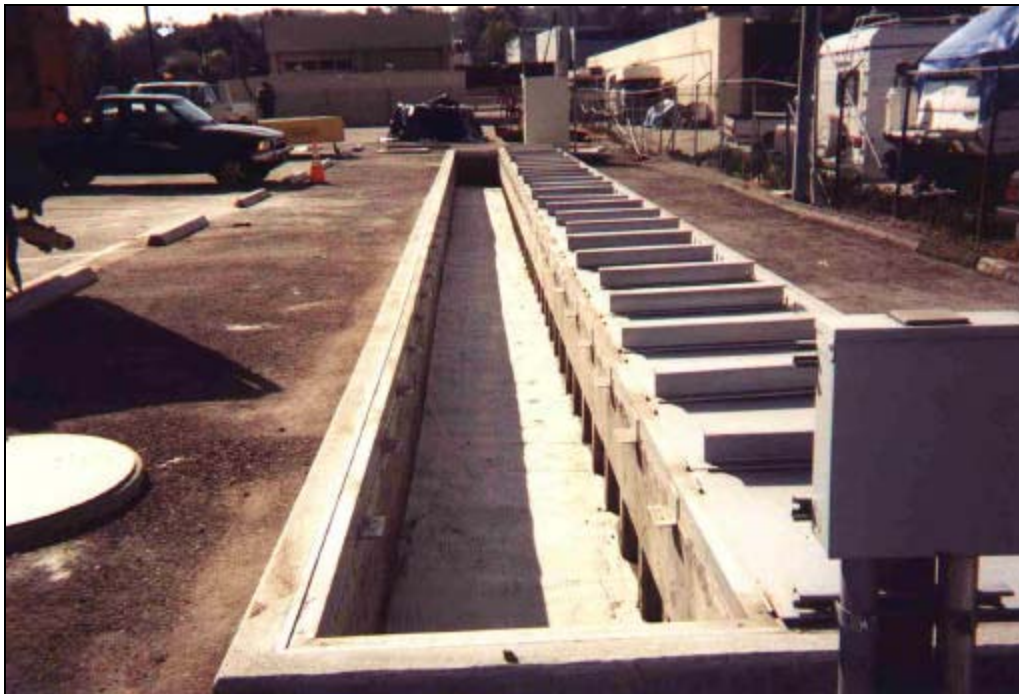
Figure 2-4 Escondido MS Delaware Sand Filter

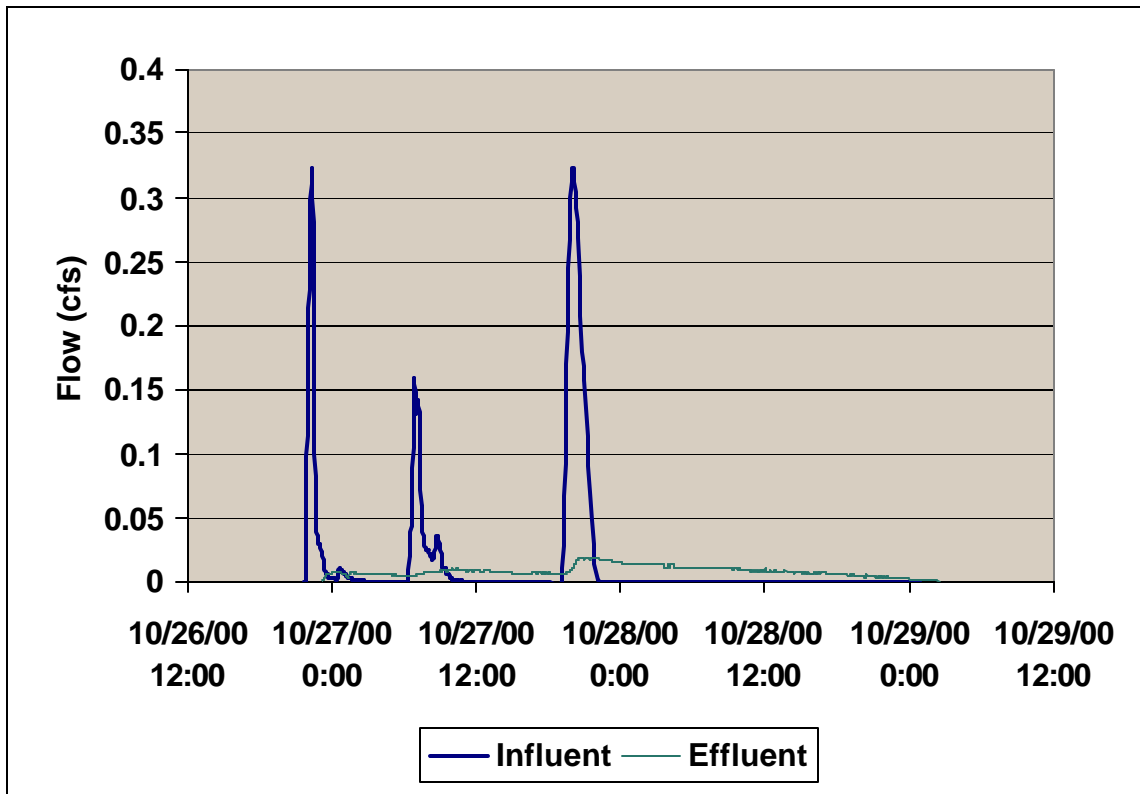
Figure 2-8 Comparison of Influent and Effluent Flow Rates at the La Costa Sand Filter

One advantage of sand filters is the attenuation in peak runoff rates and the potential for mitigation of channel erosion downstream. Figure 2-8 compares the influent and effluent flow rates for the La Costa sand filter for a single event. The peak flow rate entering the facility is nearly 18 times larger than the peak discharge rate.

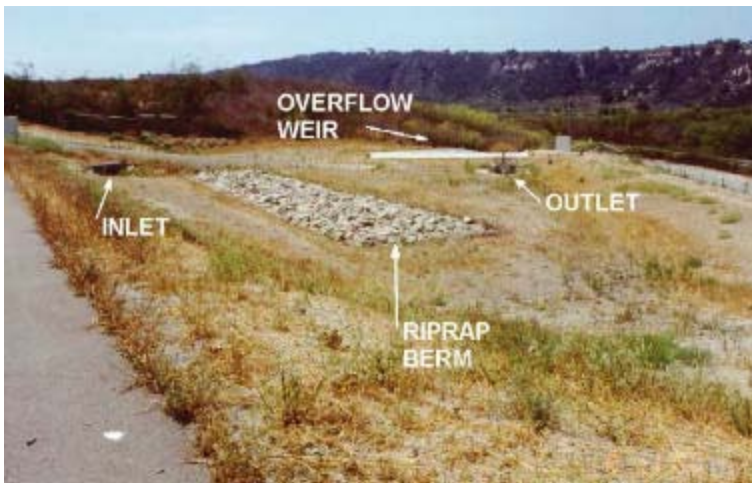
**Figure 3-3 I-5/SR-56
Unlined Basin**

Riprap berm was used to increase the flow length. Water stays pooled in berm and has caused mosquito problems.

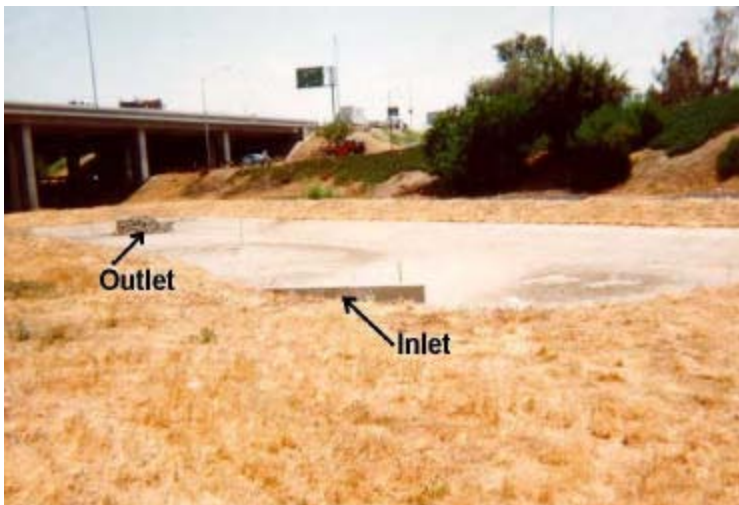
**Figure 3-4 I-5/I-605 Concrete
Lined Basin**

Some resuspension of sediments has occurred near inlet.

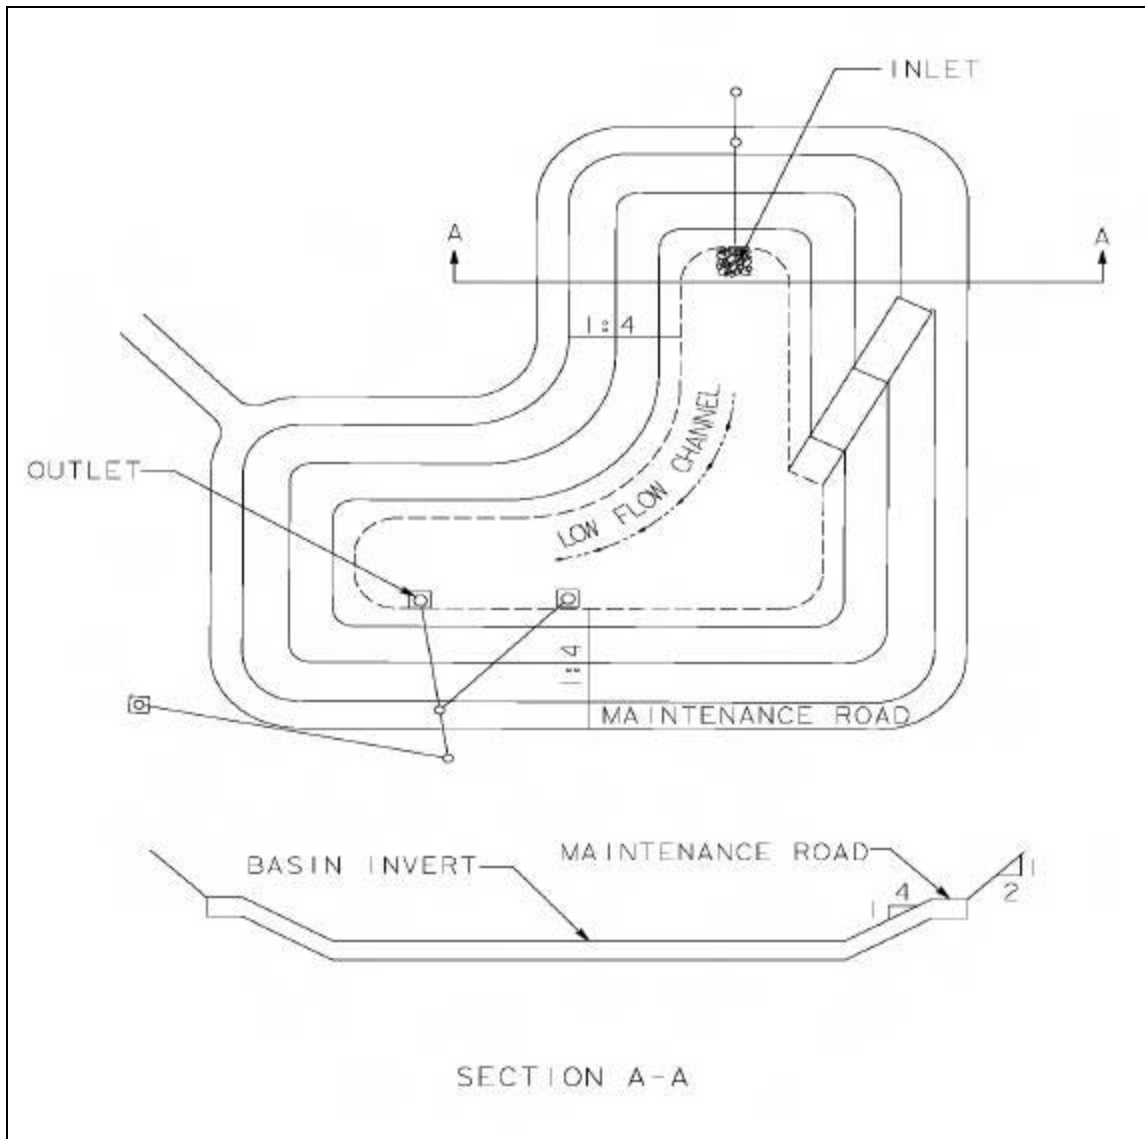
Figure 3-5 Schematic of Extended Detention Basin

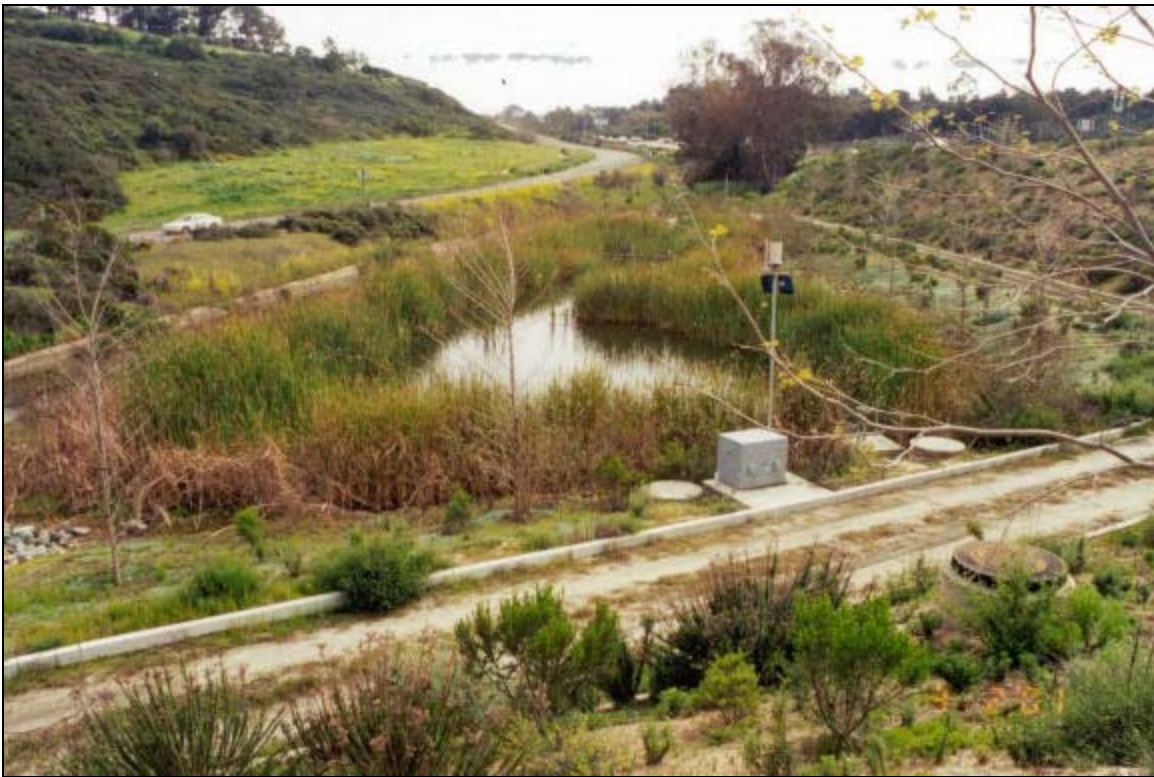
Figure 4-1 La Costa Wet Basin

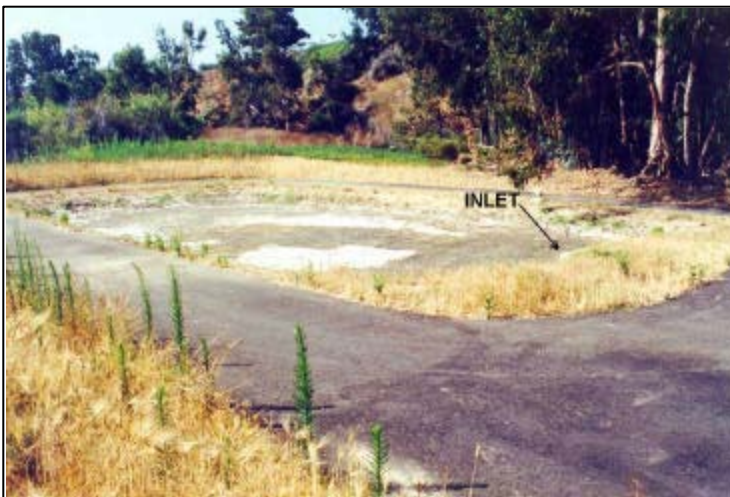
Figure 5-1 I-5/La Costa Infiltration Basin

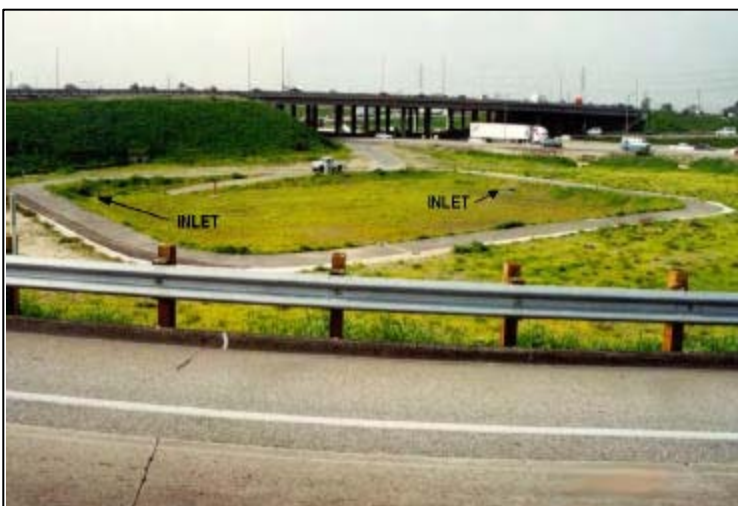
Figure 5-2 I-605/SR-91 Infiltration Basin

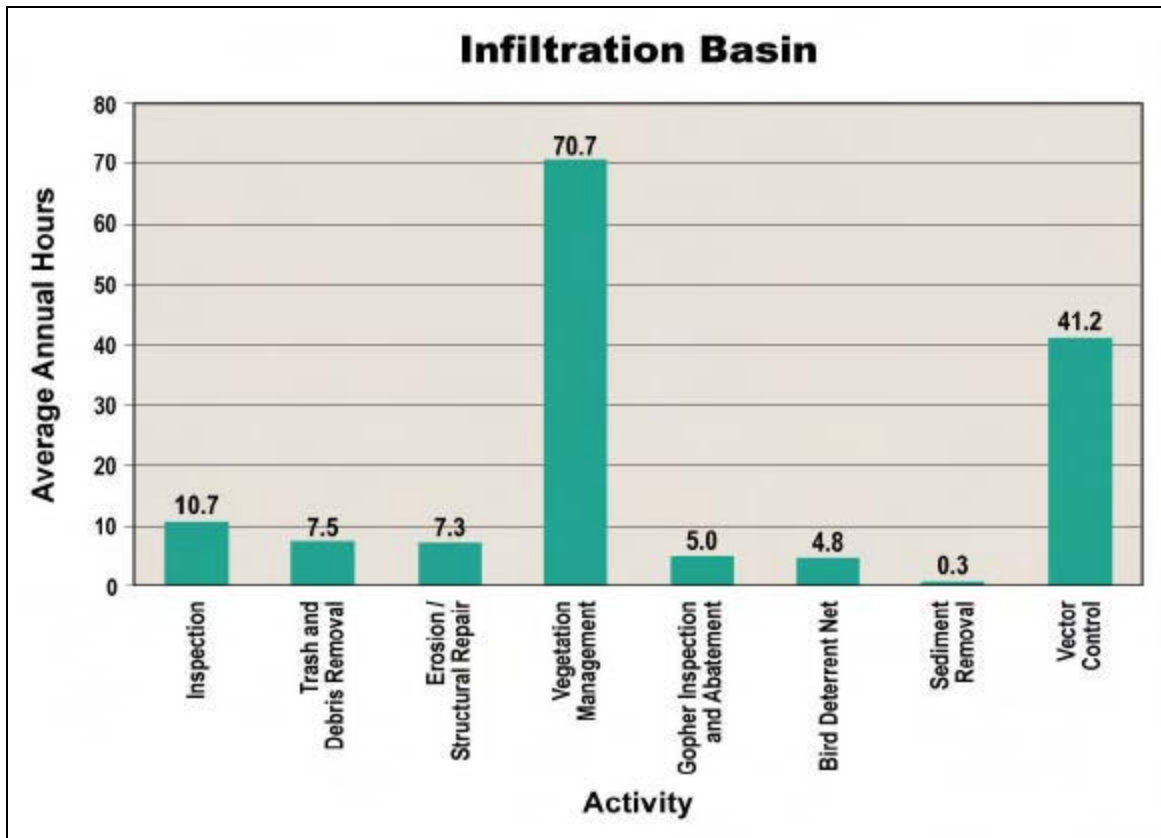
Figure 5-4 Field Maintenance Activities at Infiltration Basins (1999-2001)

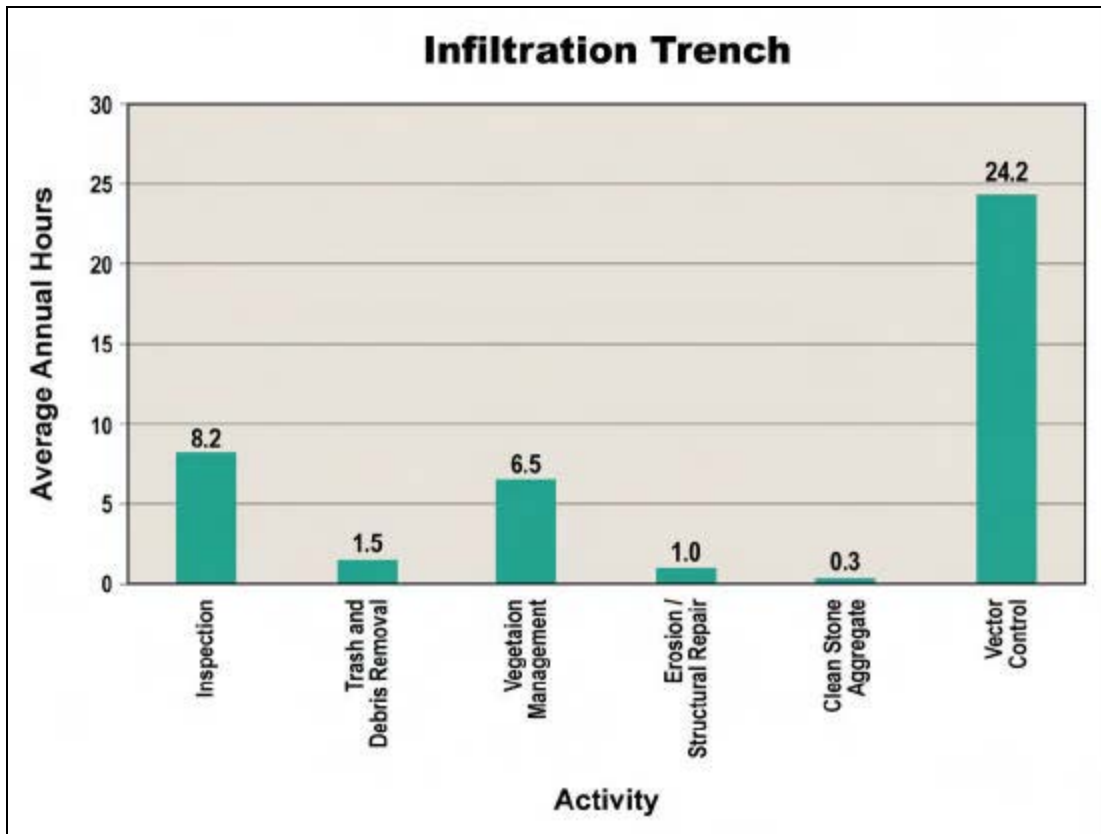
Figure 6-4 Field Maintenance Activities at Infiltration Trenches (1999-2001)

Infiltration trenches required the least maintenance of any of the BMPs evaluated in this study; approximately 17 field hours were spent on the operation and maintenance of each site, not including vector control agency hours. As shown in Figure 6-4, inspection of the infiltration trench was the largest field activity, requiring approximately 8 hr/yr. The time required for inspections reflects the requirements of the MID.

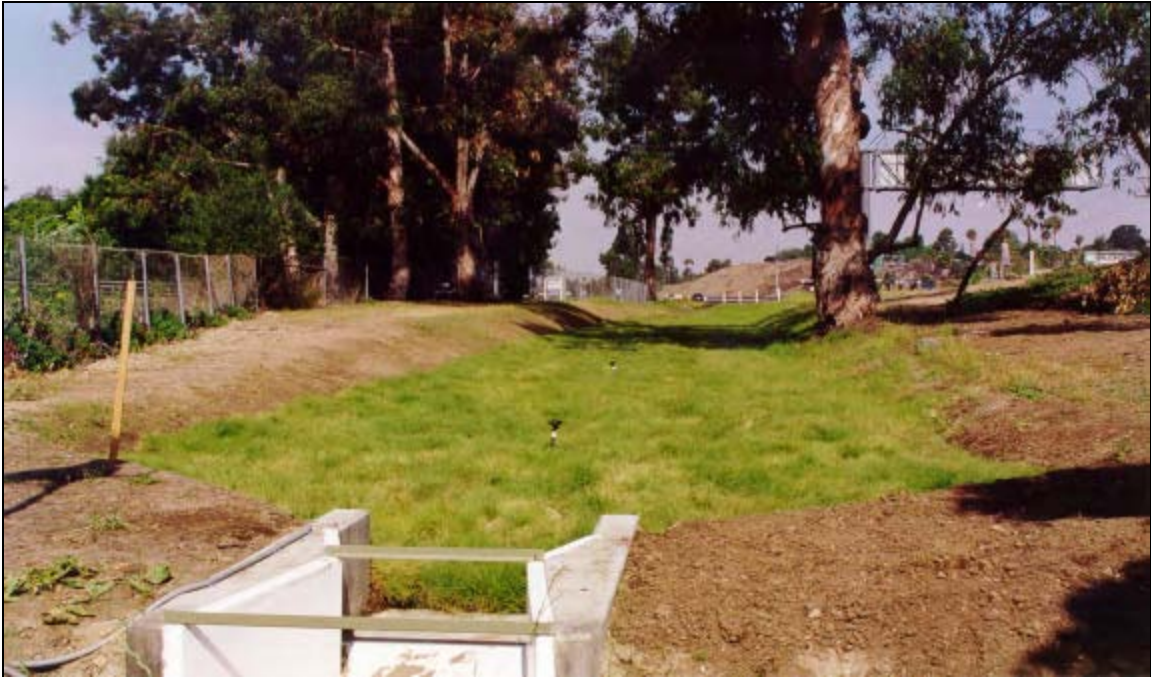
Figure 7-1 Typical Swale (SR-78/Melrose Drive)

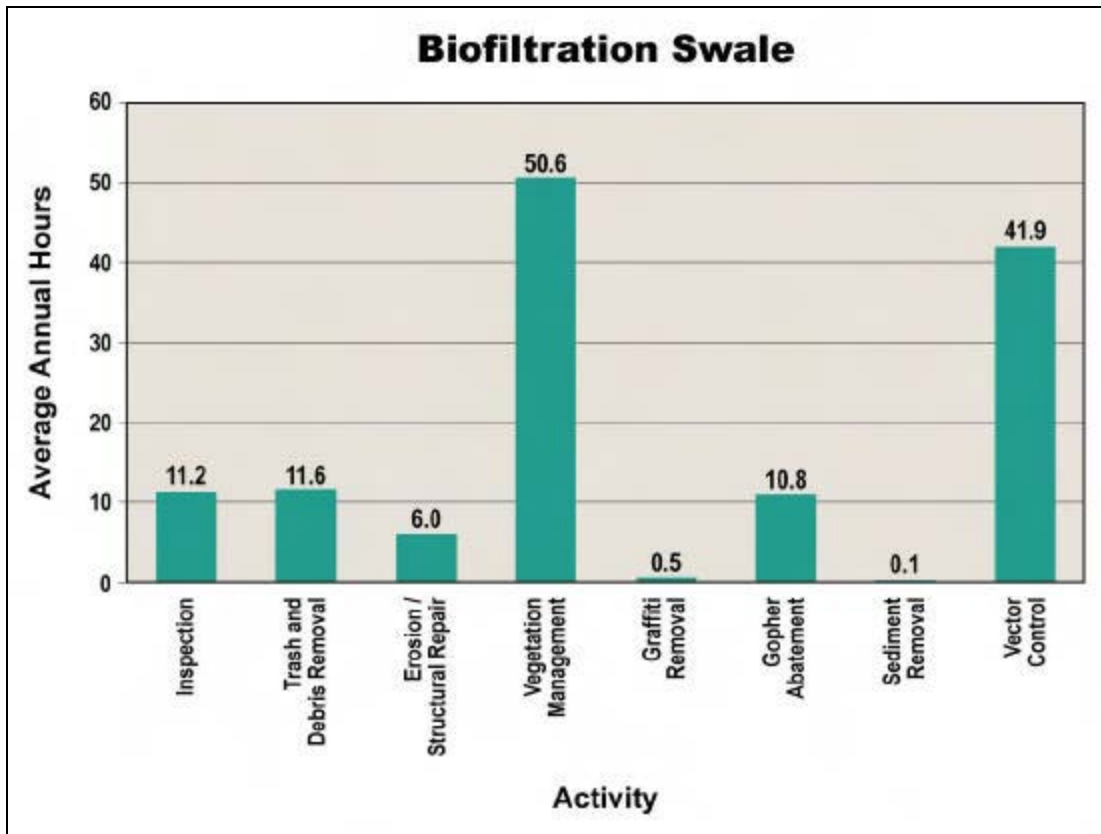
Figure 7-3 Field Maintenance Activities at Swale Sites (1999-2001)

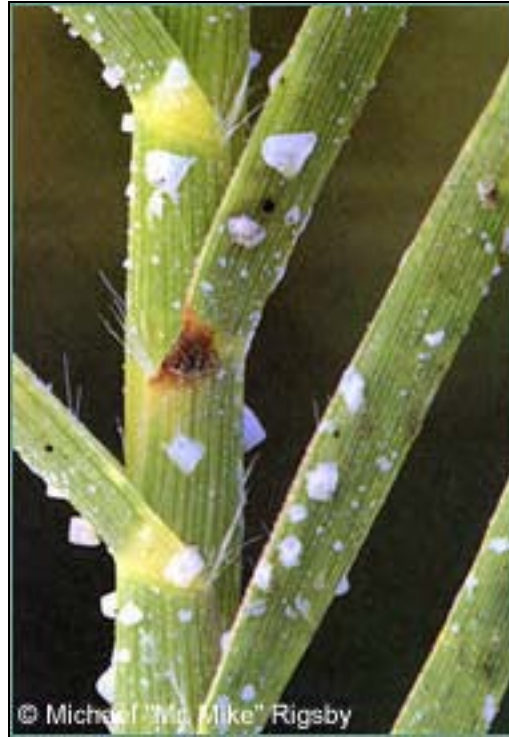
Figure 7-4 Salt Crystals on the Leaves of Salt Grass

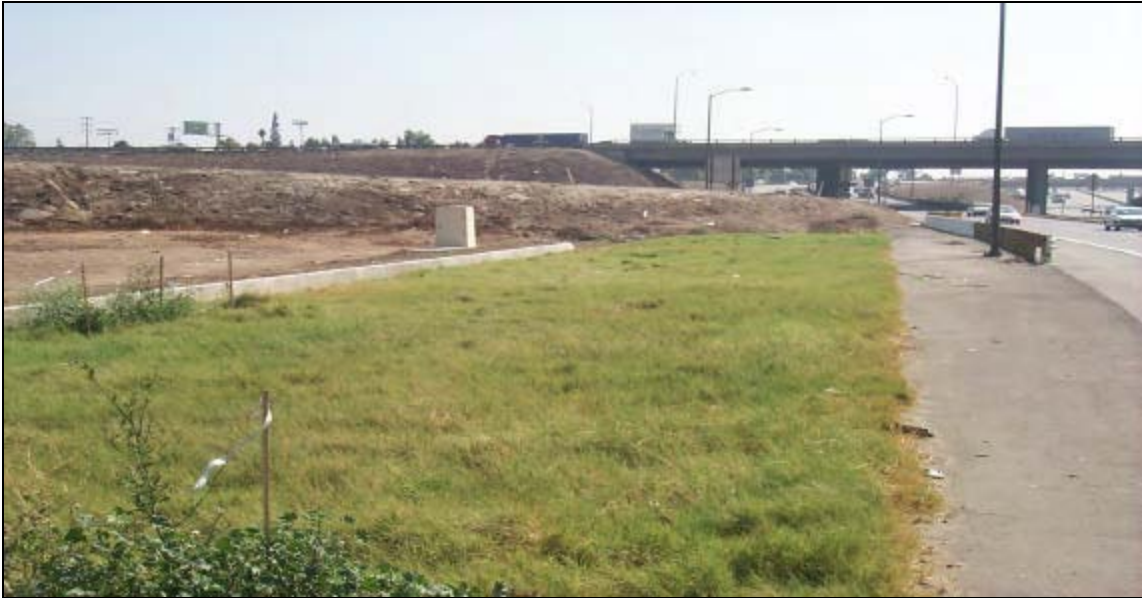
Figure 8-1 Biofiltration Strip (District 7, I-605/SR-91)

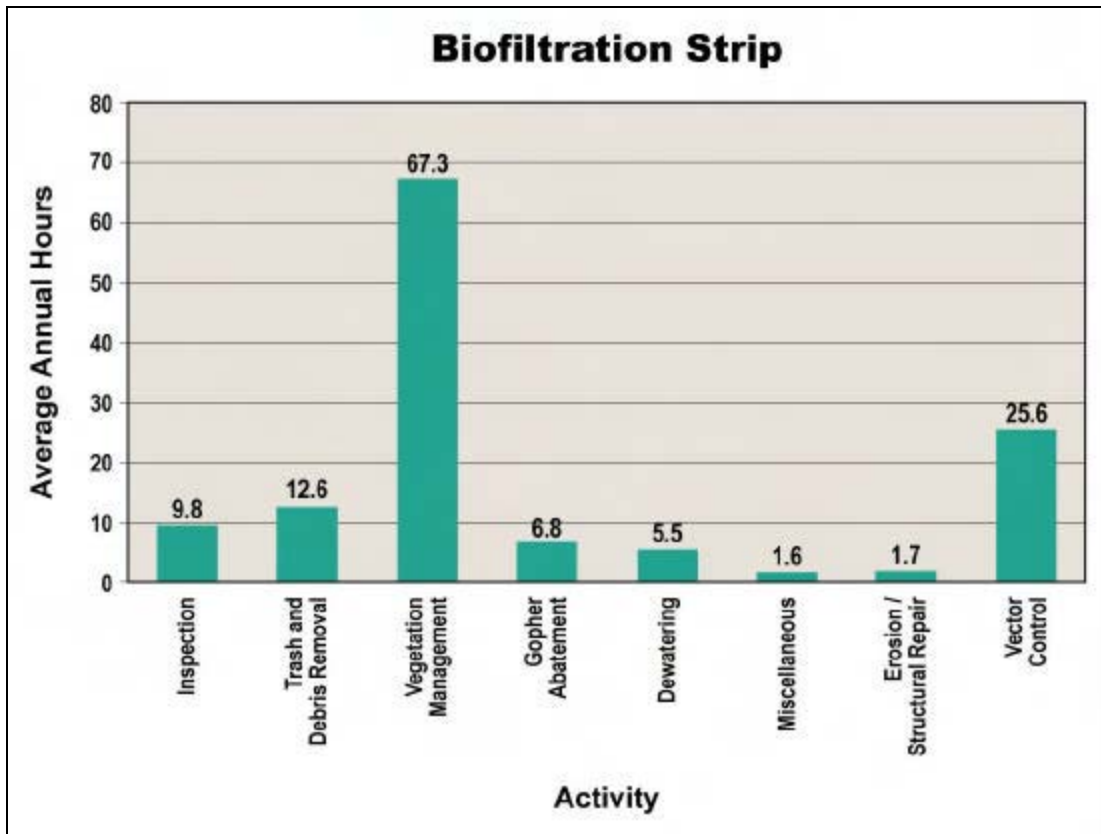
Figure 8-3 Field Maintenance Activities at Strip Sites (1999-2001)

The number of hours of field maintenance activities is shown below in Figure 8-3. An average of about 105 hr/yr were spent on these activities, not including 26 hours for vector control activities. Of these, more than 67 hr/yr were required for vegetation management, included mowing, weeding, irrigation, and rehabilitation of bare areas, to comply with the requirements of the MID. An additional 6 hours were needed just to remove the drain plugs and drain the level spreaders.

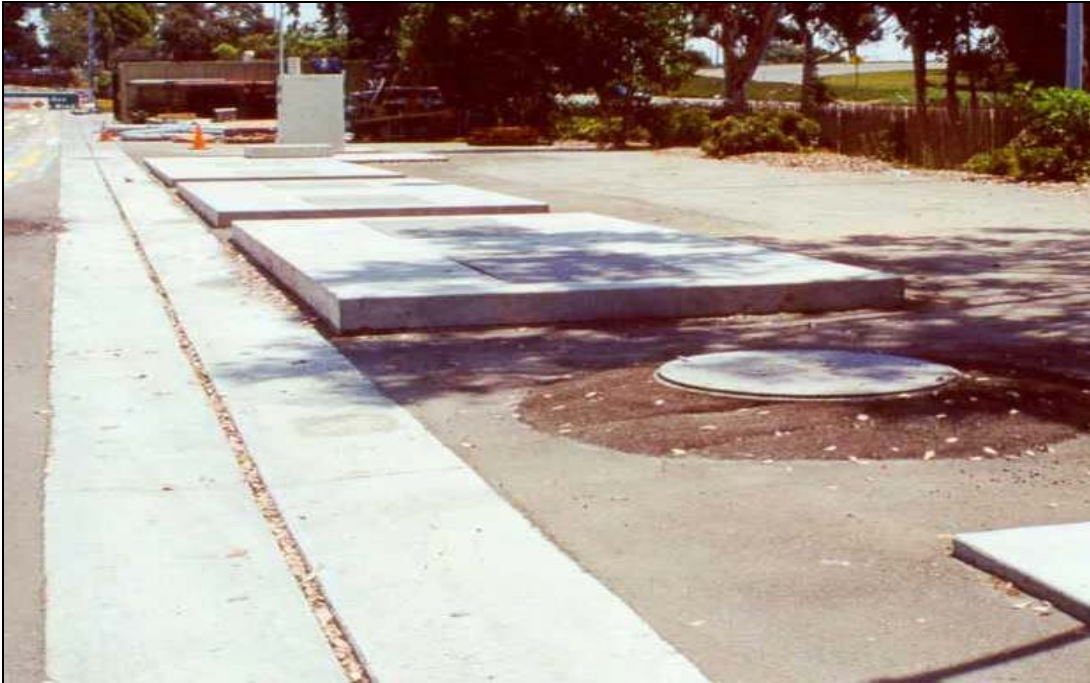
Figure 9-2 Surface View at Kearny Mesa

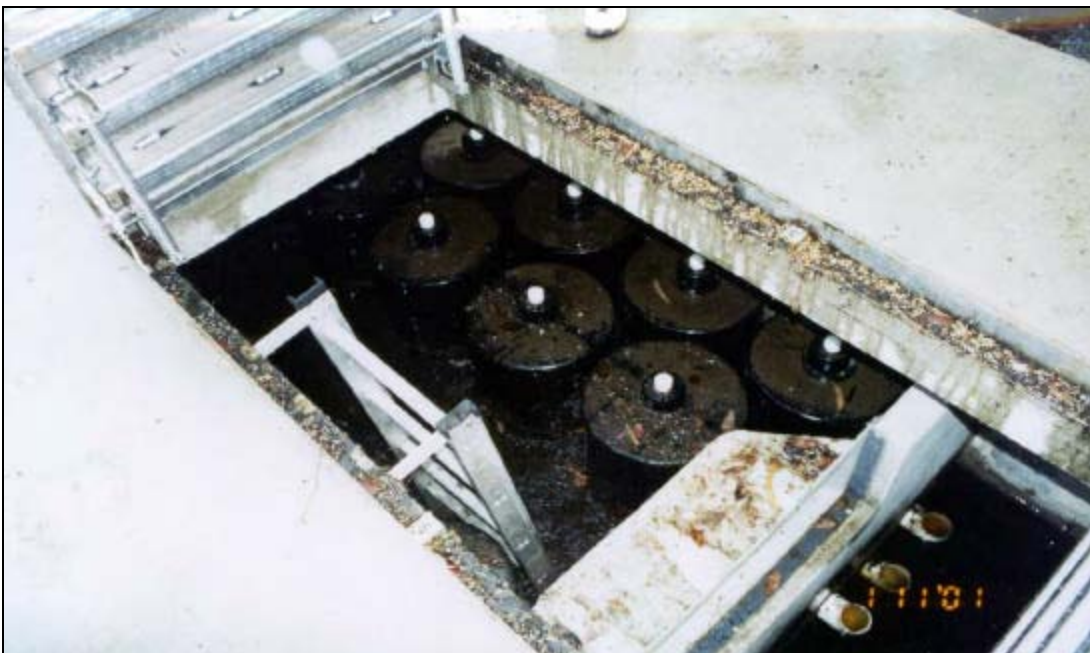
Figure 9-3 Internal View at Kearny Mesa

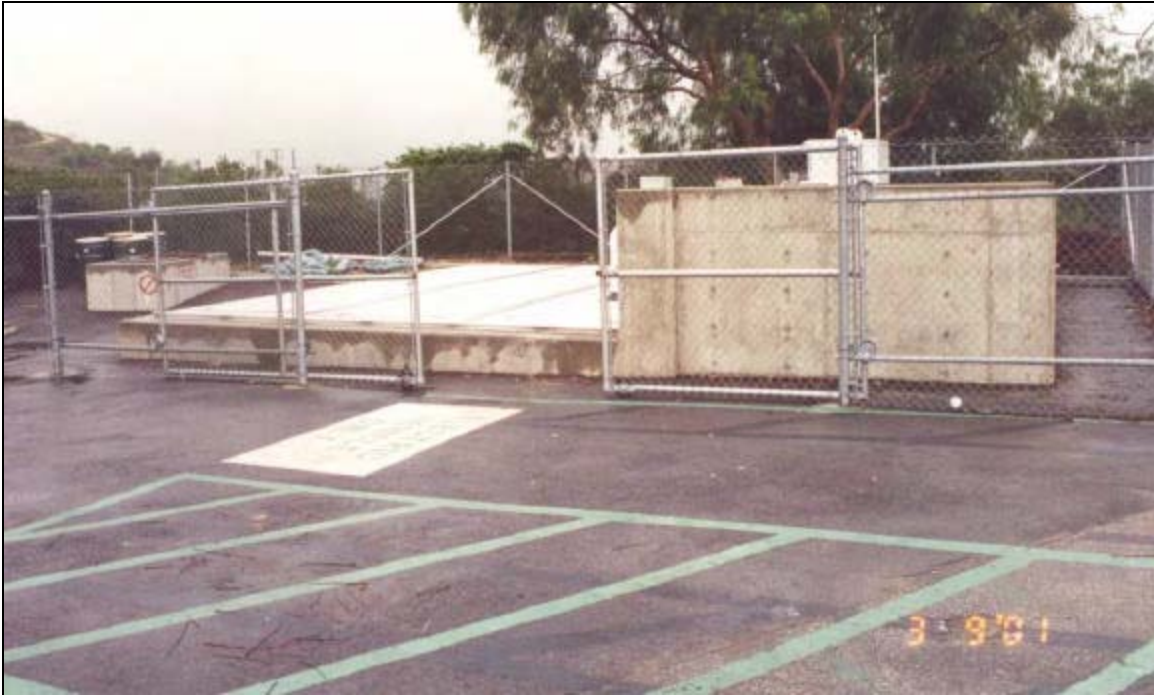
Figure 10-2 Surface View of an MCTT (Via Verde P&R)

The MCTTs were designed as a three-stage device as illustrated in Figure 10-1. Figures 10-2 and 10-3 show internal and external views of the MCTTs, respectively. The first stage consisted of a catch basin with sump and packed column aerators. This was followed by the main settling chamber that included tube settlers to improve particulate removal and sorbent pillows to capture floating hydrocarbons. The sedimentation basin was designed so that the water quality volume is held above the tube settlers, which are nominally 0.6 m deep with about 0.3 m of plenum space underneath. The sorbent pillows are "Oilup Sorbent Blue Booms." The dimensions of the MCTTs are summarized in Table 10-2.

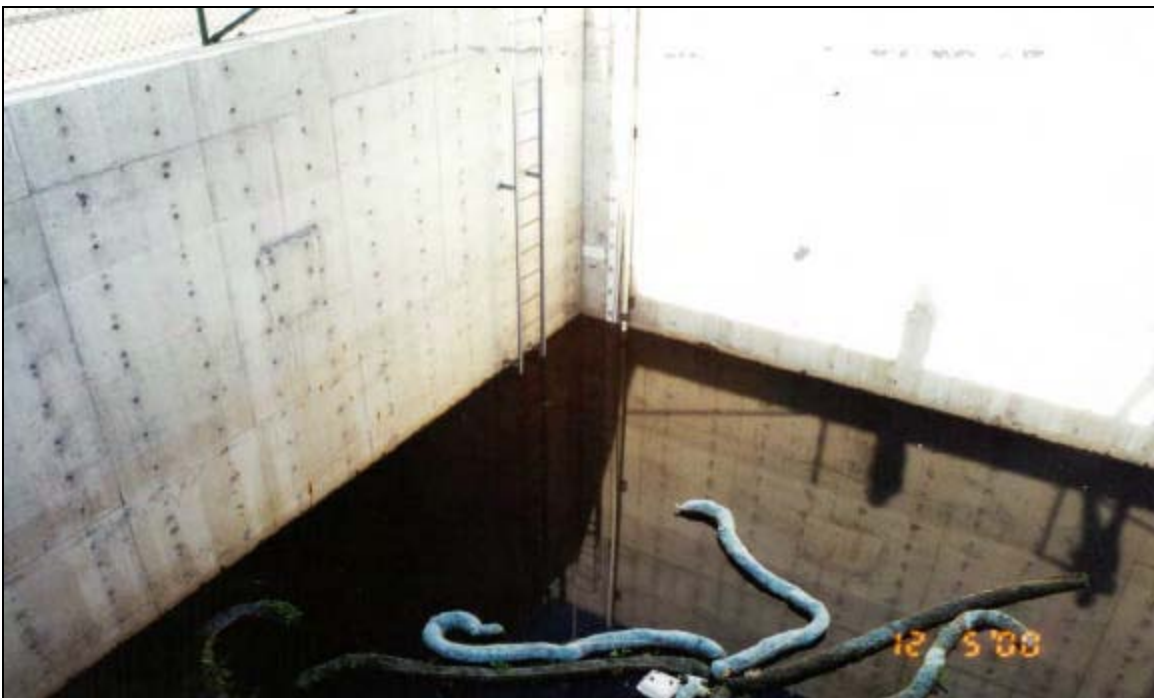
Figure 10-3 Internal View of an MCTT (Lakewood P&R)

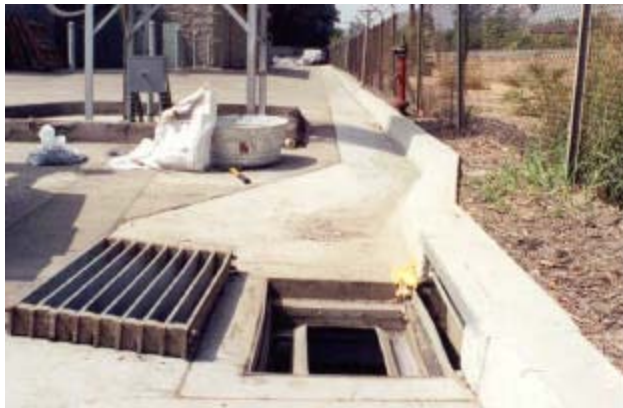
Figure 11-3 FossilFilter™

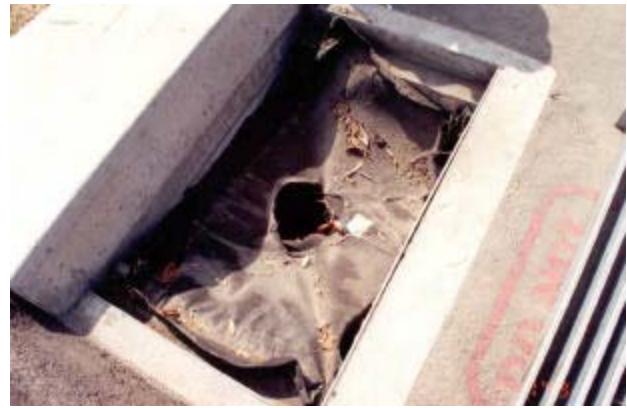
Figure 11-4 StreamGuard™

The StreamGuard™ DII is a conical-shaped porous bag made of polypropylene fabric and contains an oil absorbent polymer. As stormwater flows through the insert, the fabric absorbs oil and retains sediment. Floating oil and grease are absorbed by the absorbent polymer. The insert has two overflow cutouts near the top of the cone to allow bypass when the fabric’s flow-through capacity is exceeded. A schematic is shown in Figure 11-2. An installation is shown in Figure 11-4.

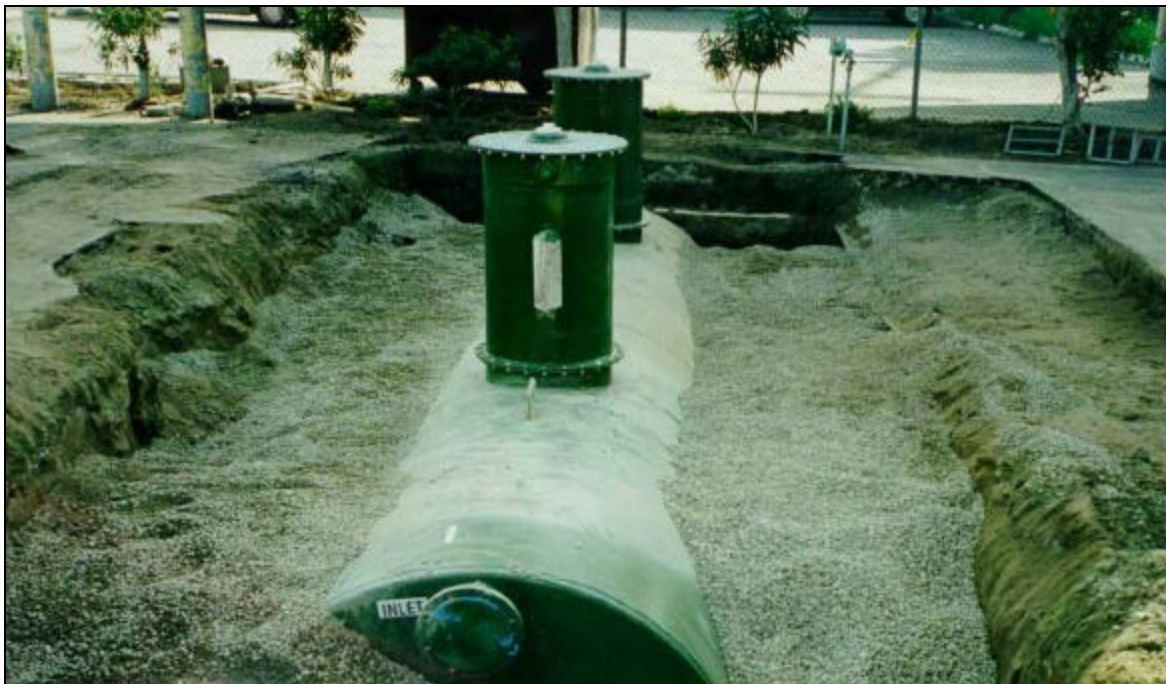
Figure 12-2 Alameda OWS

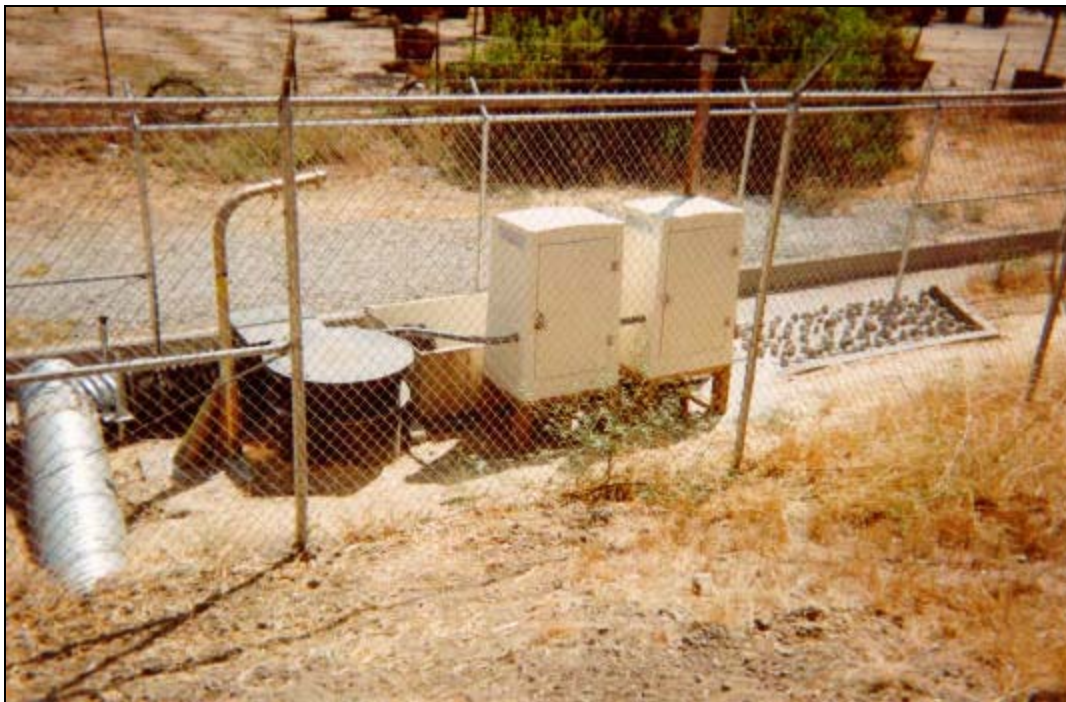
Figure 13-3 CDS® Unit (I-210 / Filmore)

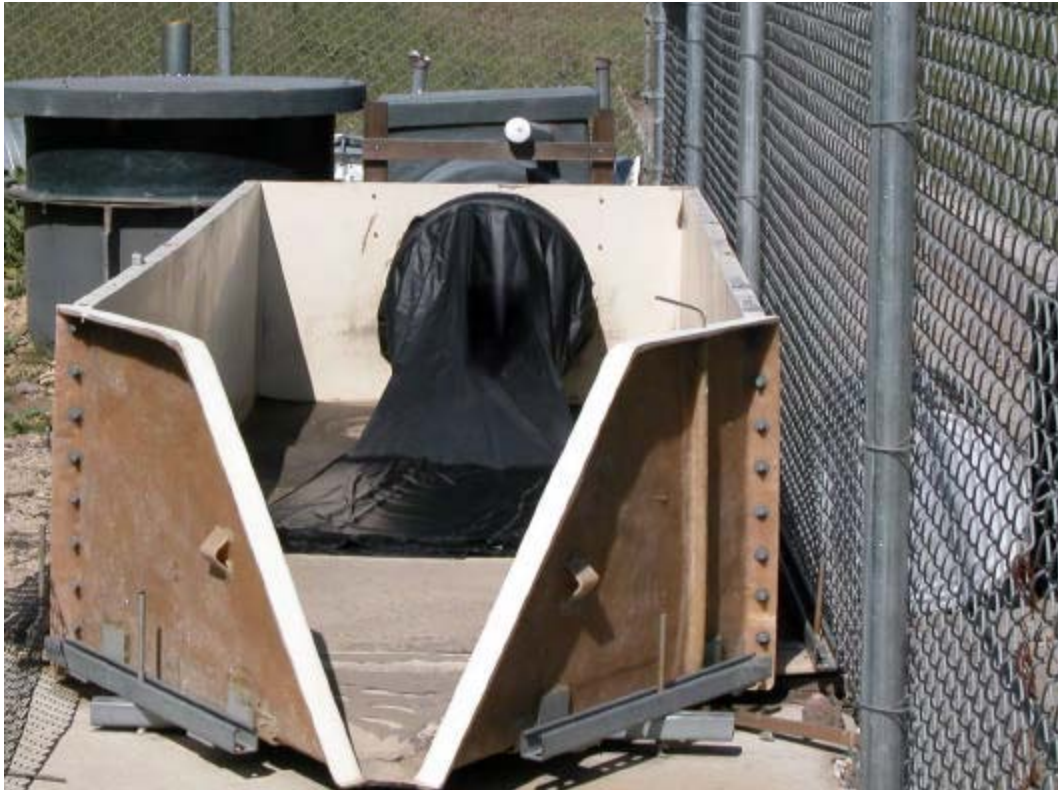
Figure 13-7 CDS® Mosquito-Proofing Bag
